## Nondestructive Evaluation of Bridges

*Paul S. Fisk, President NDT Corporation*

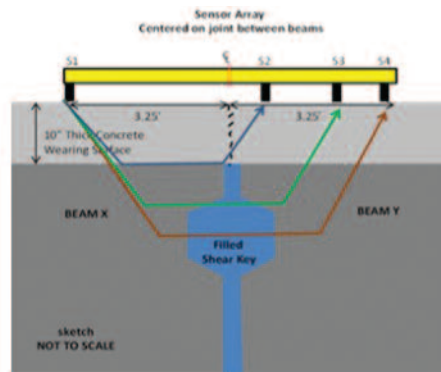
Sonic/ultrasonic array and testing configuration for crack depth assessment.

NDT Corporation conducted sonic/ultrasonic pulse velocity measurements on box beam bridges at Houston International Airport to determine if visible cracking coincident with the spacing and location of the joints between box beams extended to and possibly through the concrete filled shear keys. Depending on the depth of a crack, wave velocity will be lower for measurement across a crack. A full depth crack through the shear key would inhibit the propagation of the waves, resulting in no discernible signal arriving at the sensor.

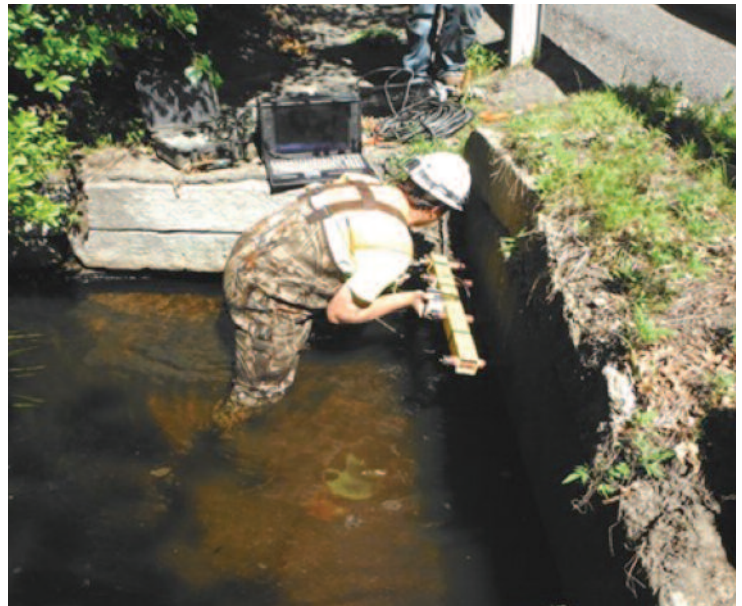
Sonic/ultrasonic pulse velocity measurements being taken on a bridge in the field.

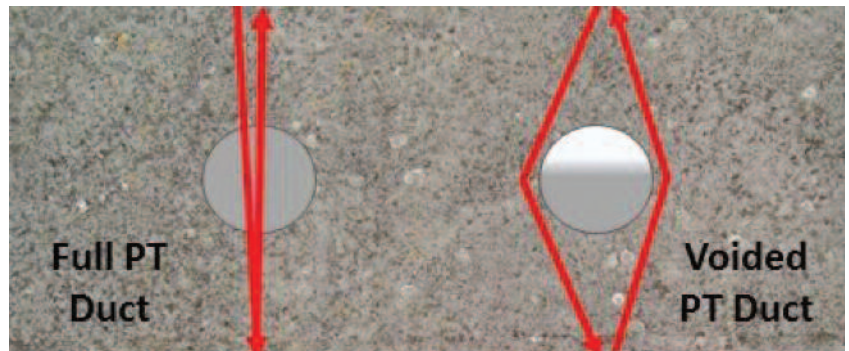
Sound waves pass through full PT ducts, but deflect and slow as they pass around voided PT ducts.

NDT Corporation has successfully used nondestructive impact echo testing to identify specific locations within internal post tensioning ducts where grout voids and soft grout exist. Nondestructive testing results are verified by drilling a small hole to the duct, opening the duct with tools designed for this task, and verifying grout condition with probing and documenting tendon corrosion with video borescope imaging. The results of these investigations are used to determine appropriate repair methods and prepare repair bid documents. In the last 15 years, NDT Corporation has successfully completed investigations of PT ducts on bridges including:

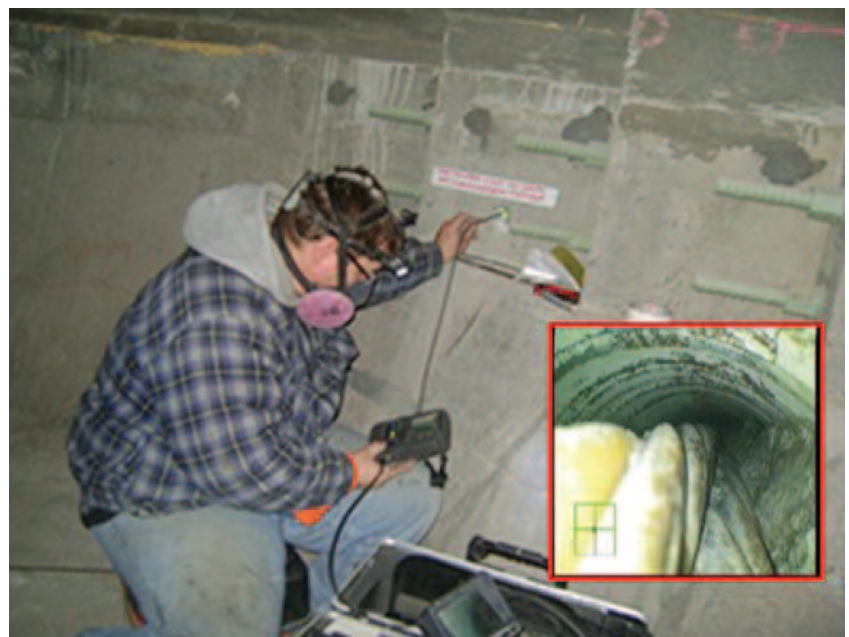
Documentation of a PT duct void via a borescope inspection.

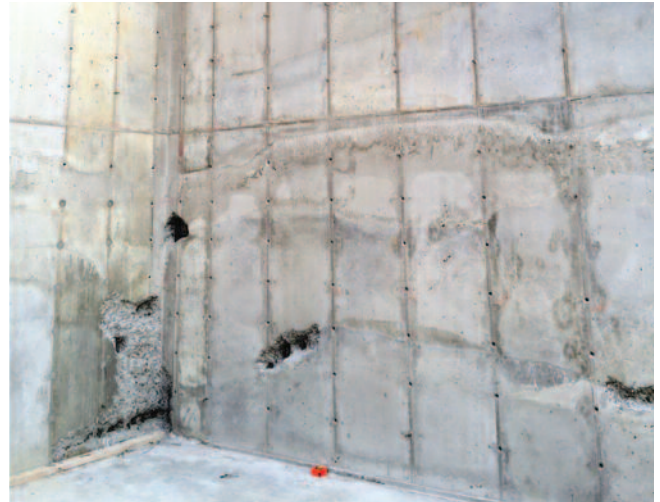
Pulse velocity measurements determined the extent of the weak areas in the recently poured concrete.

The questions that arise are: Where, how extensive and how severe is the problem? NDT Corporation has successfully used direct through velocity measurements with tomographic imaging to identify the locations of low velocity concrete associated with weak, voided, fractured or honey combed concrete. These measurements can be repeated after repairs have been made to determine how effective the repairs have been.

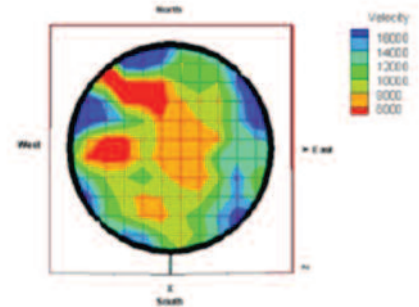
Tomographic image of a support column cross-section show weak concrete as red areas.
