Measuring the Condition of Prestressed Concrete Cylinder Pipe

John Marshall, P.E.I., J.W. Marshall and Associates, and Paul S. Fisk, President NDT Corporation

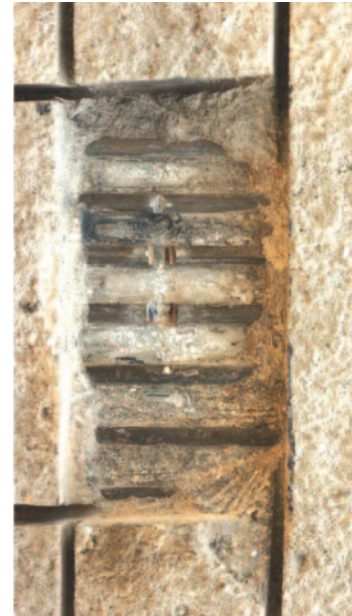
Sonic/ultrasonic measurements effective in detecting cut pre-stressing wires; subsequent tests indicate that the mortar coating and adjacent uncut wires kept the pre-stress in tension away from the cut areas. *Image courtesy of Lewis Engineering and Consulting, Inc.*

Tests on an out-of-service 60-inch diameter PCCP pipe to detect broken wires, shows the effectiveness of sonic/ultrasonic measurements in detecting cut pre-stressing wires. With cuts in eleven, five and six wires in different locations, sonic/ultrasonic measurements were made along continuous line of coverage across all three wires cut locations. The mortar coating on both sides of the cut wires was well bonded to the pre-stressing wires.

The sonic/ultrasonic test results indicated loss of full thickness resonant frequencies for data acquired directly over cut wires and no change in velocity or resonant frequency data for measurements where wires were not cut indicating the affect of the broken wires was confined to the cut wire areas. These measurements were repeated on an annual basis for six years with no significant changes in velocity values or resonant frequency results, indicating that the mortar coating and adjacent uncut wires had kept the pre-stress in tension away from the cut areas.

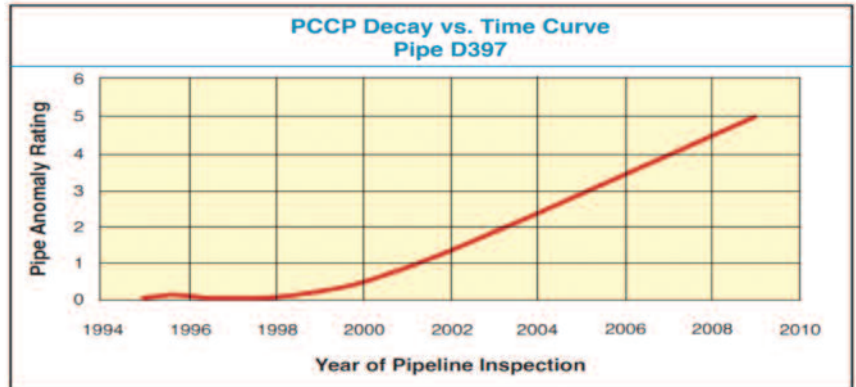
Periodic sonic/ultrasonic testing provides the data needed to develop a pipe decay curve vs. time chart. *Image courtesy of J.W. Marshall & Associates.*

The testing results are repeatable over time. A subsequent sonic/ultrasonic survey provides the data needed to develop a pipe decay curve vs. time plot.
